CORROSION EVALUATION ON FLY ASH AND SILICA FUME CONCRETE USING NDT METHODS

ABSTRACT: Corrosion of reinforced concrete is a major problem that can weaken a structure and even cause it to fail. On a macro level, this affects the safety and durability of important structures like bridges, buildings, and roads, leading to high repair costs and safety risks. On a micro level, corrosion begins with chemical reactions between steel and concrete, resulting in cracks, surface damage, and weakening of the concrete, which in turn reduces its strength and performance. This study examines the effects of using industrial waste, namely fly ash (FA) and silica fume (SF), as alternative solutions to improve reinforced concrete's corrosion resistance and mechanical performance. Concrete is made with FA substitutions of 10%, 20%, and 30% of the cement weight, and SF of 5%, 10%, and 15%, respectively. Compressive strength and flexural tests were performed to evaluate the mechanical properties, and corrosion analysis was conducted through non-destructive testing (NDT) to assess the corrosion resistance. Corrosion testing was carried out with accelerated corrosion for 48, 96, and 168 hours. Microstruct

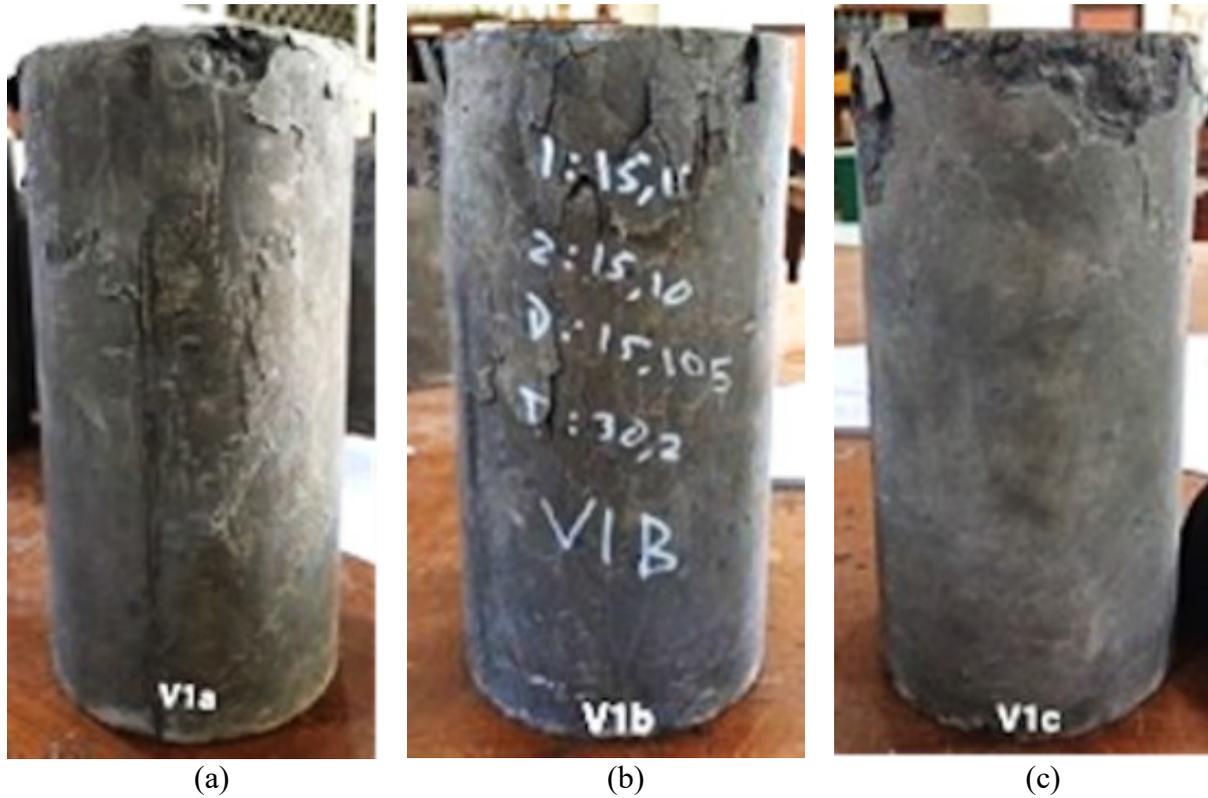
Figure 8 shows the collapse pattern in cylindrical concrete with variations of 10% FA and 5% SF. Figs. 8(a), (b), and (c) show different crack patterns. Figure 8(a) and (b) show the same crack pattern, namely cone and shear, whereas Figure 8(c) shows the shear crack pattern. The failure mechanism in concrete, particularly the development of cone cracking and shearing, is influenced by several factors, including aggregate distribution, interfacial transition zones (ITZ), and localized stress concentrations. Uneven aggregate size can lead to non-uniform stress distribution within the matrix, but this alone does not comprehensively explain the observed failure modes. Instead, cone cracking is typically initiated by point loading or high compressive stress beneath loading points, where tensile stresses radiate outward. Figure 9 shows the collapse pattern in cylindrical concrete with 20% FA and 10% SF. Figure 9(a) shows a sliding crack pattern, Figure 9(b) shows a columnar crack pattern, and Figure 9(c) shows a cone crack pattern. These different cracking patterns were caused by uneven or poorly adhered capping of the concrete surface, resulting in varying tension concentrations in each test piece. Figure 10 shows the collapse pattern of the cylindrical concrete with 30% FA and 15% SF. Figure 10 (a), (b), and (c) show similar crack patterns, namely shear crack patterns. A shear crack pattern occurs in concrete with low compressive strength and is ductile. Shear crack patterns in concrete have significant implications on structural performance, as they indicate potential failure in the load transfer mechanism, particularly in beams and structural members subjected to transverse loads. These cracks can reduce the stiffness, load-bearing capacity, and

Figure 8. Concrete crack pattern with FA 10% and SF 5%

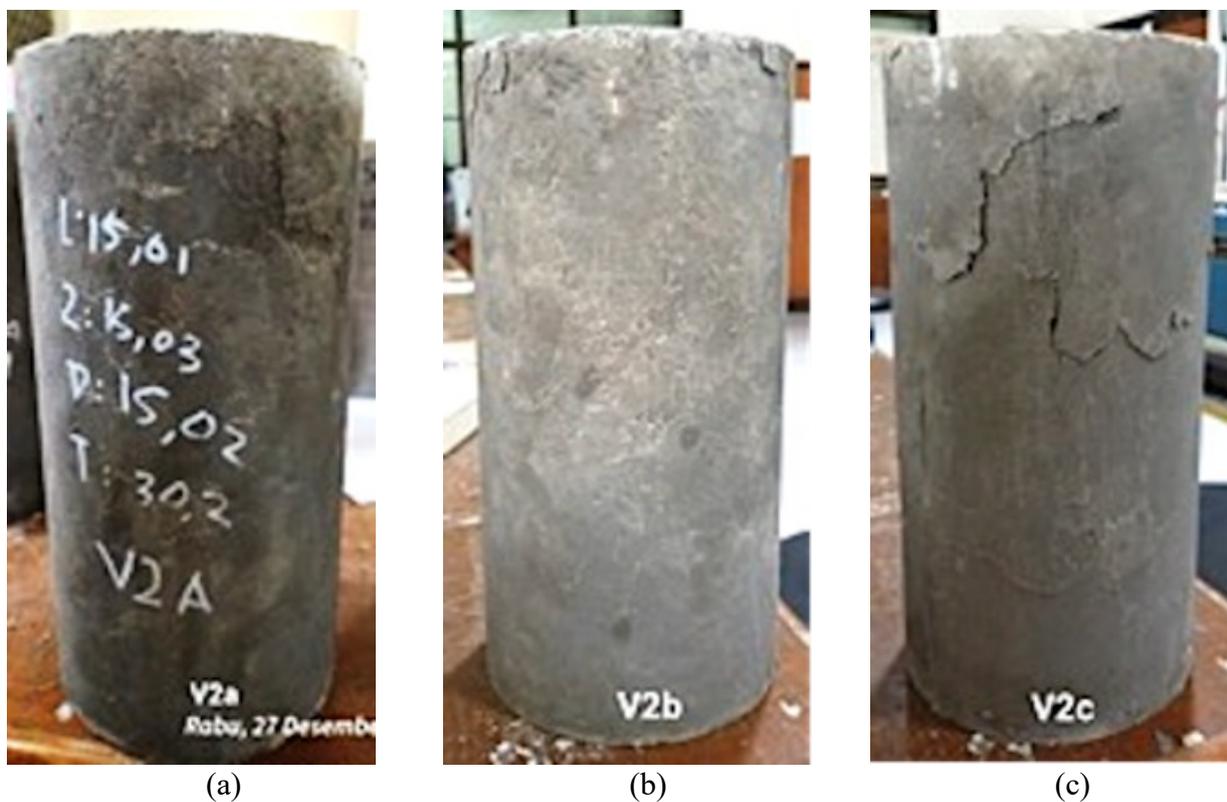
Figure 9. Concrete cracking pattern FA 20% and SF 10%

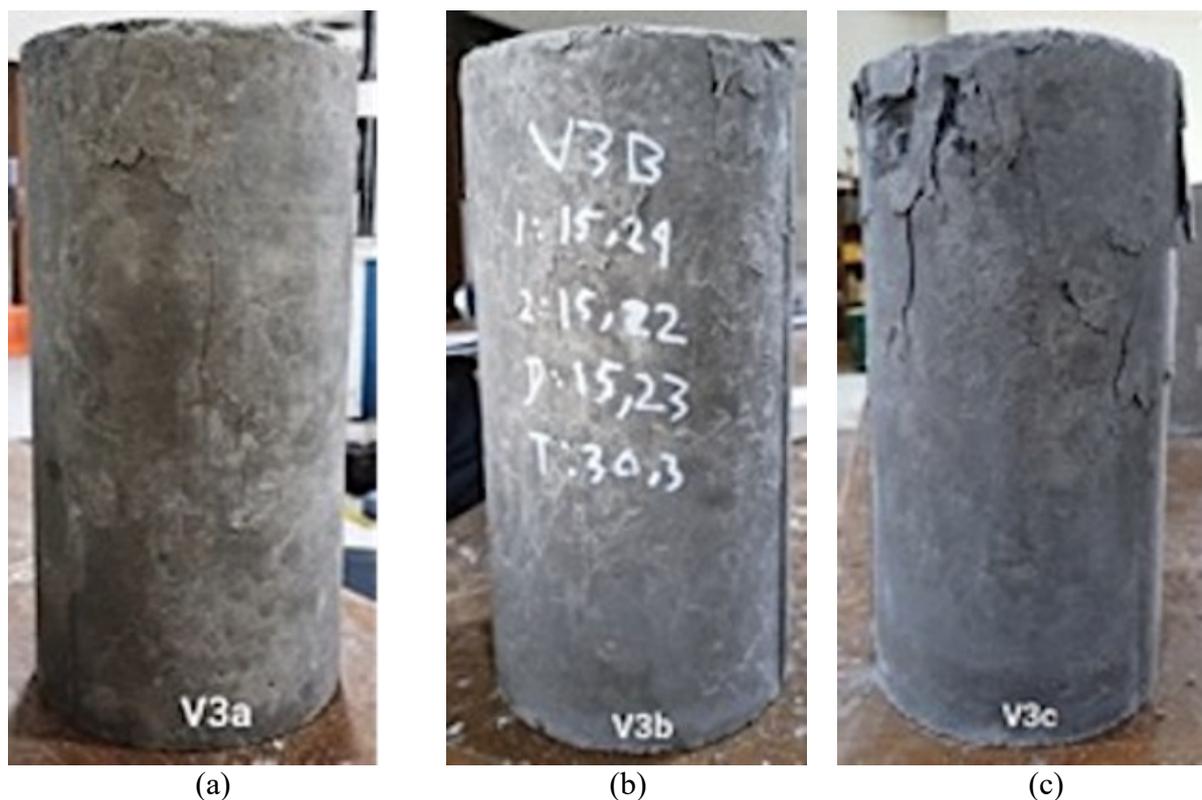
Figure 10. Concrete cracking pattern FA 30% and SF 15%

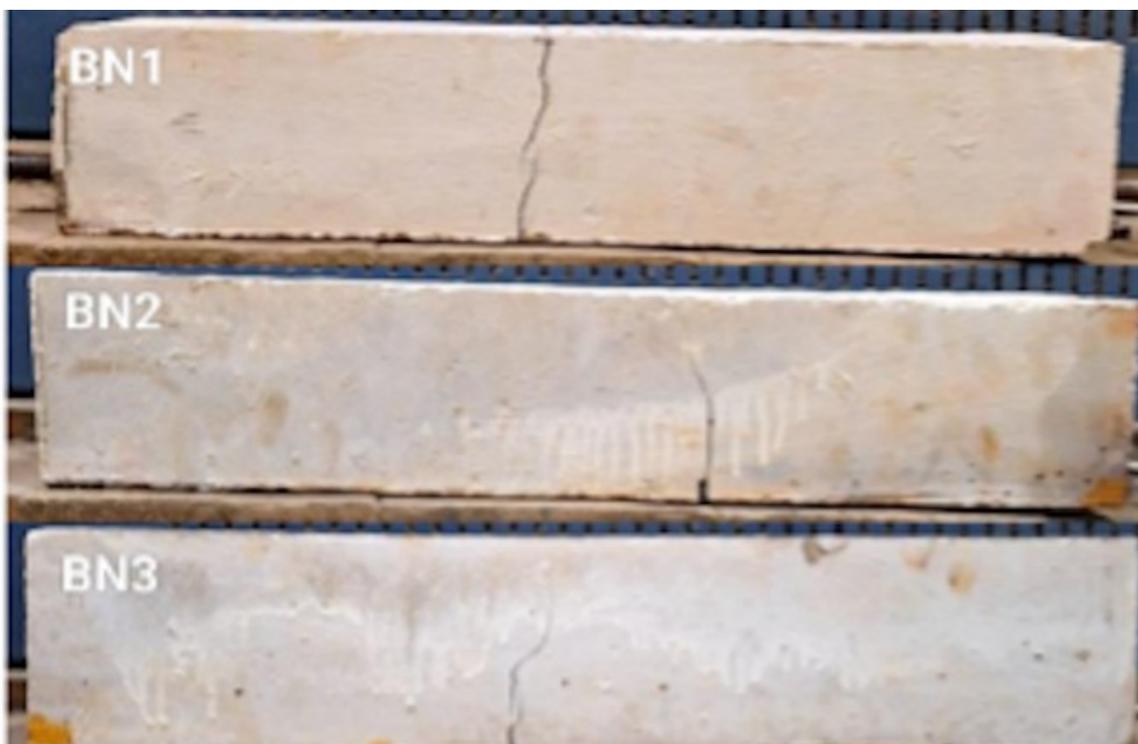
The initial crack in the BN specimen was a bending crack, as shown in Figure 17. Based on the observation of the crack pattern, an initial crack appeared at the bottom of the beam near the load. The cracks widened as the load increased, but no other cracks were observed in the beam. The beam collapsed after deformation with a deflection of 2.604 mm in beam BN1 (48 h corrosion), in beam BN3 2.154 mm (96 h corrosion), and 1.426 mm in beam BN2 (168 h corrosion).

Figure 17. BN beam crack pattern

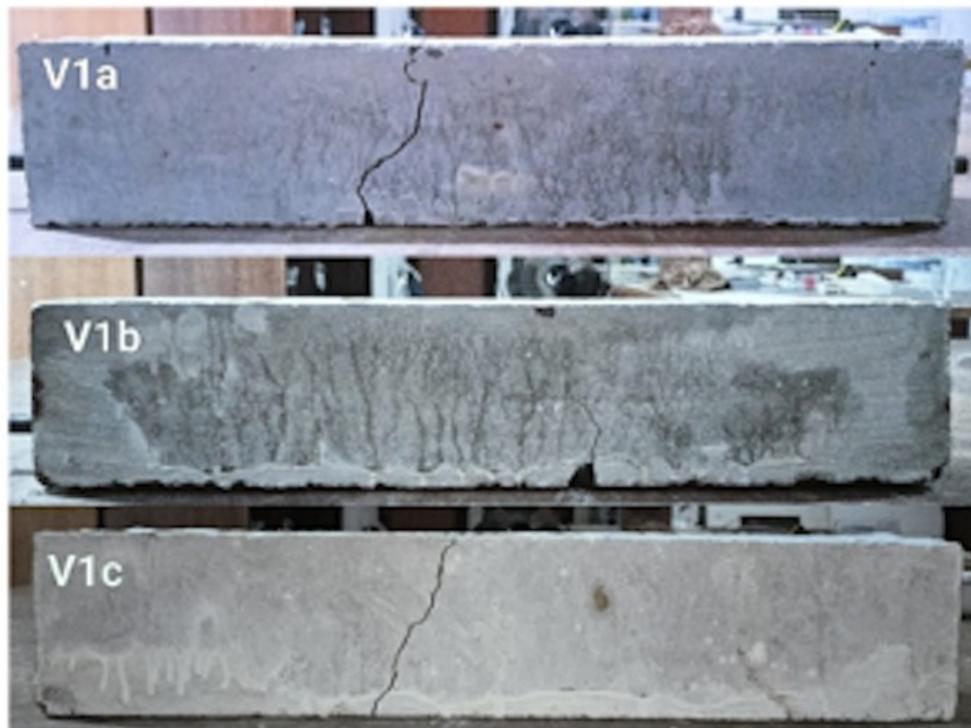
Figure 18. V1 beam crack pattern

The initial crack in the V1 specimen was flexural, as shown in Figure 18. Based on the observation of the crack pattern, an initial crack appeared in the area under the beam close to the load. As the load increased, the cracks widened, and no other cracks were observed along the beams. The beam collapsed after deformation, with a deflection of 3.544 mm on the V1a

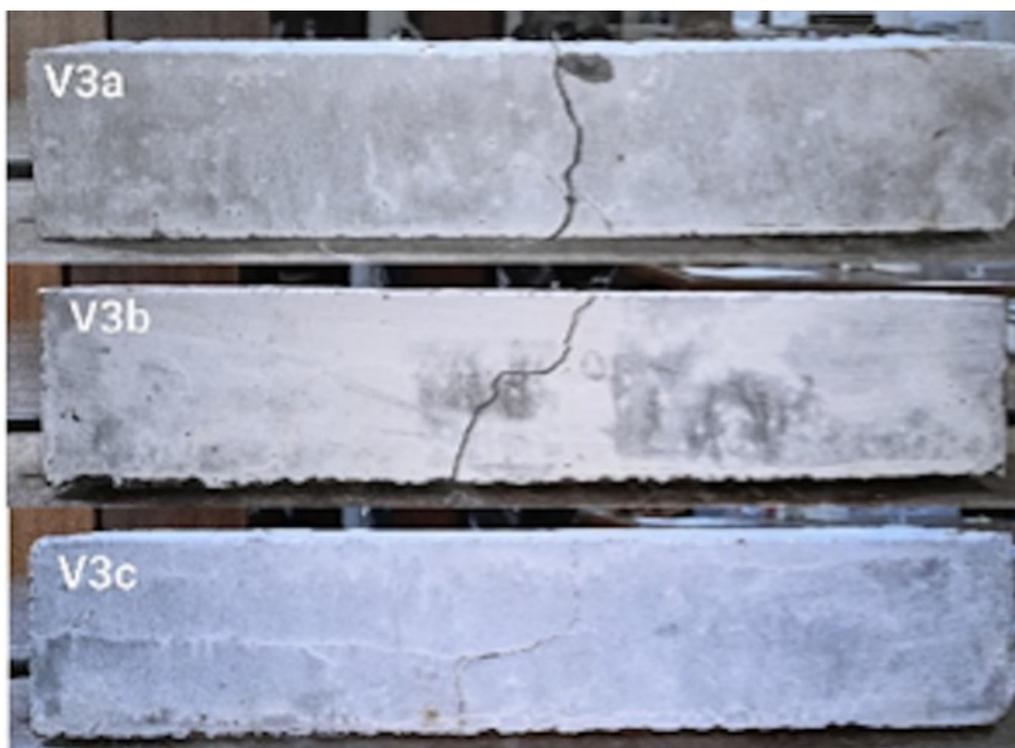
Figure 20. V3 beam crack pattern

The initial crack in the V1 specimen was flexural, as shown in Figure 20. Based on the observation of the crack pattern, an initial crack appeared in the area under the beam close to the load. As the load increased, the cracks widened, and no other cracks were observed along the beams. The beam collapsed after deformation with a deflection of 5.342 mm on the V3a beam (48 h corrosion), 0.910 mm on the V3b beam (96 h corrosion), and 1.610 mm on the V1c beam (168 h corrosion).
