# Unfortunate Series of Fractured Cannula: Rare Venous Access Complications

This case series described four cases of fractured intravenous cannulas managed in a tertiary centre without vascular access services, over 6 months, aiming to raise awareness of this rare but preventable complication.

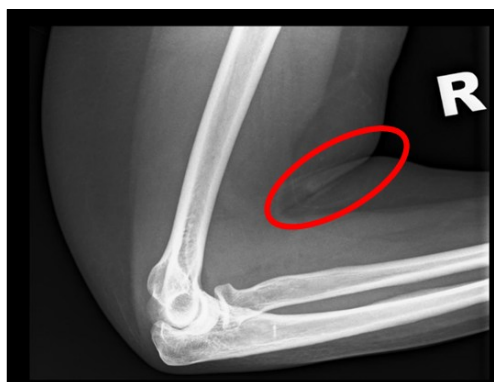
cannula was removed. This was further confirmed by bedside ultrasound and plain radiography of the right upper limb (Figure 1). Consequently, the patient underwent vascular exploration under local analgesia, and the fractured component was successfully retrieved (Figure 2). The procedure and recovery process were uneventful.

**Figure 1:** Radiograph of the right elbow in lateral view. An elongated hyperdense foreign body was observed in the superficial layer of the right antecubital fossa.

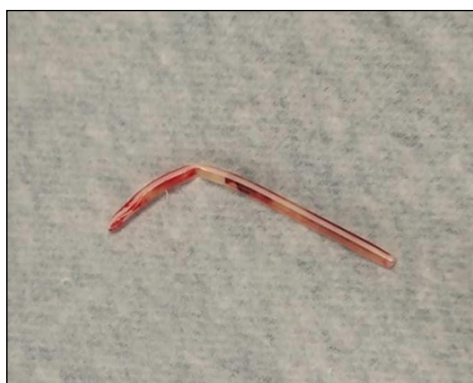
**Figure 2:** The retrieved fractured catheter

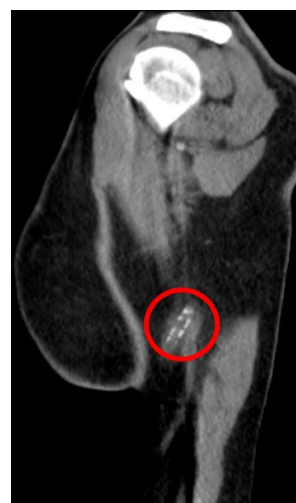
A 61-year-old male with community-acquired pneumonia received intravenous antibiotics through a 20-gauge right antecubital fossa cannula. The same cannula remained in place for more than four days and continued to be used as it appeared externally intact, with no signs of complication. However, on the sixth day of insertion, the cannula started leaking and was removed. Upon removal, it was noted that its tip had fractured and remained inside the vein. The fractured segment was not visible on elbow radiography. A CT scan of the right upper limb revealed an elongated hyperdense structure, partly in the subcutaneous tissue and partly within the superficial vein, consistent with a fractured catheter fragment (Figure 3). The fragment was successfully removed via ultrasound-guided incision and exploration under local analgesia.

**Figure 3:** Elongated hyperdense structure partly in the superficial vein and partly in subcutaneous tissue representing a fractured catheter fragment.
