# Full mouth rehabilitation for severely worn dentition using fixed prostheses and tooth-supported partial overdenture: a case report

## Abstract

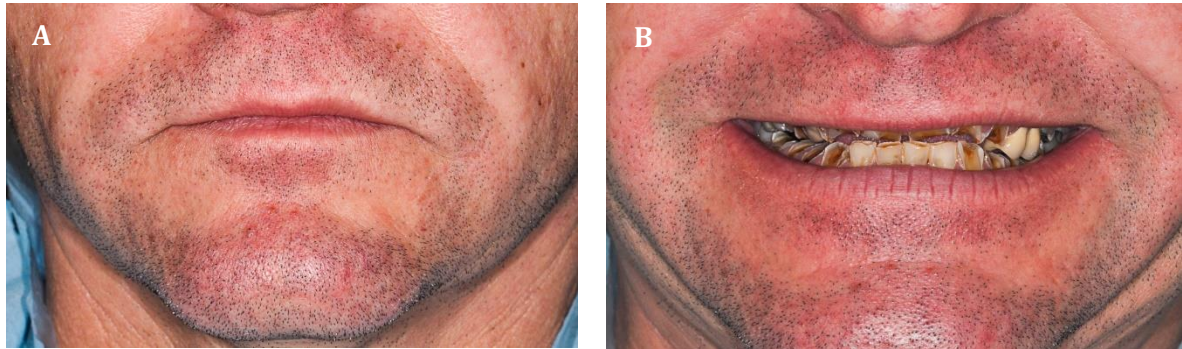
Figure 1. Frontal view. Overclosure of lips at rest (A) and on smiling (B), the occlusal disharmony was evident.

Extraorally the patient presented with reduced lower facial height associated with overclosure of his lips and prognathism of his mandible. On smiling, no obvious gingival tissue showing, however there was disharmony of occlusal plane orientation (Figure 1A-B).

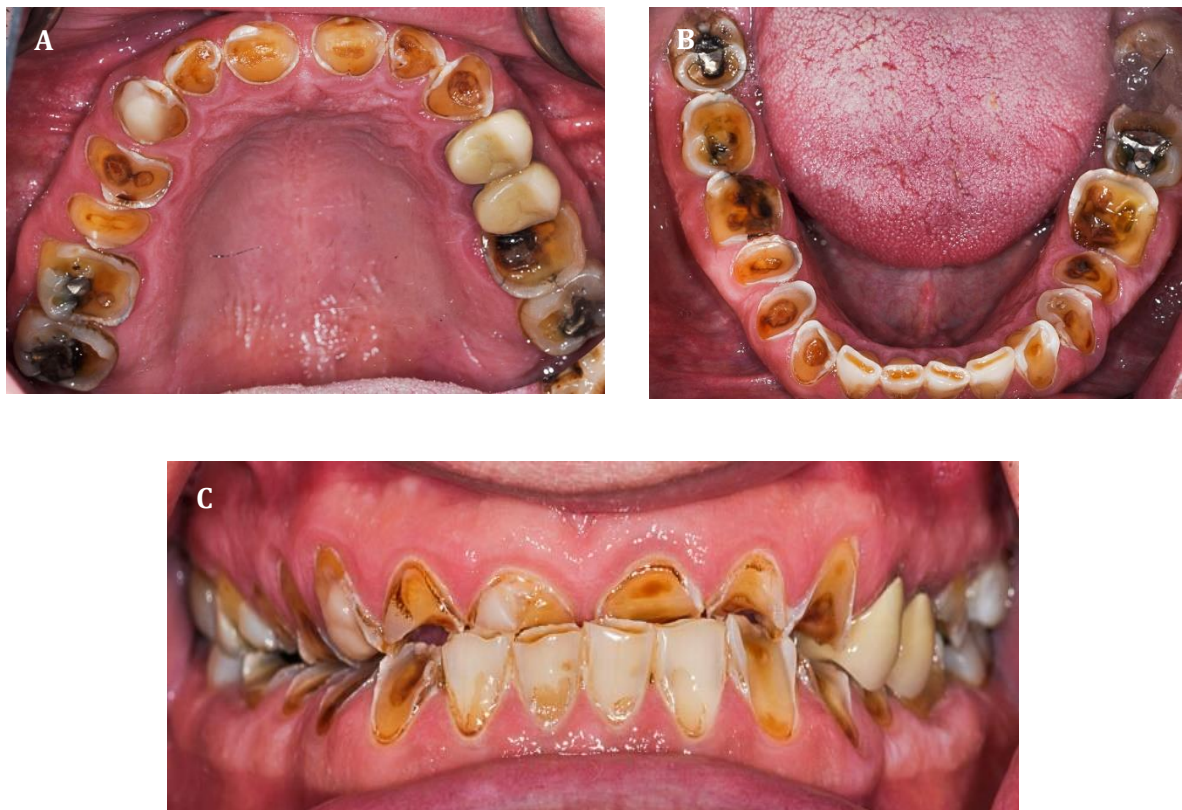
Figure 2A-C. Intraoral view. Severe tooth wear (combination of erosion, attrition and abrasion) could be seen. Dentoalveolar compensation has taken place leading to reduced interocclusal space for restorative works.

His oral hygiene was fair and there was no periodontal problem. Clinical and radiographic examinations as well as diagnostic casts revealed generalized moderate to severe tooth wear (combination of attrition, erosion and abrasion). Most affected teeth had worn down to the gingival level with severely short clinical crown height, dentin exposure and visible pulpal outline (Figure 2A-C). Few teeth were sensitive to air blow and his tooth 13 was tender to palpation and percussion. Basic Erosive Wear Examination (BEWE) indicated score 3 for all the sextants.

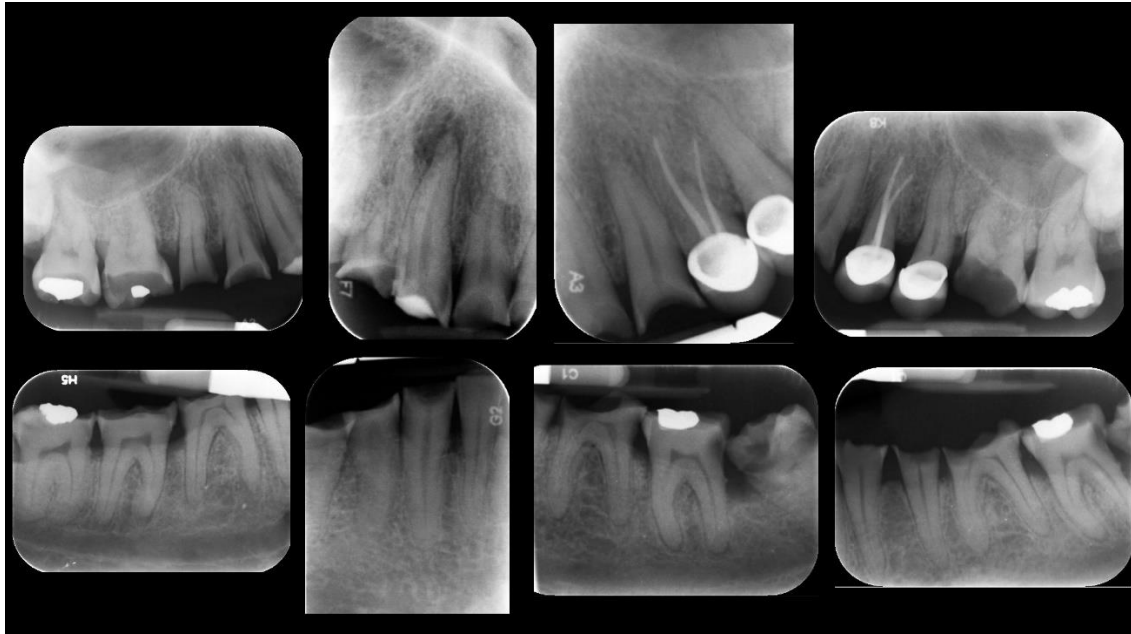
Figure 3. Full mouth periapical radiographs (pre-operative)

Full mouth periapical radiographs were taken which revealed periapical radiolucencies on teeth 13, 36, 37 and 47. There were also presence of radiolucencies on tooth 37 (disto-occlusal) confirming the intraoral finding of carious lesion. The

radiographs also showed generally short root morphology on most of his teeth (Figure 3). All teeth responded to electric pup test and cold test except teeth 13, 37 and 47, which indicates pulp necrosis.

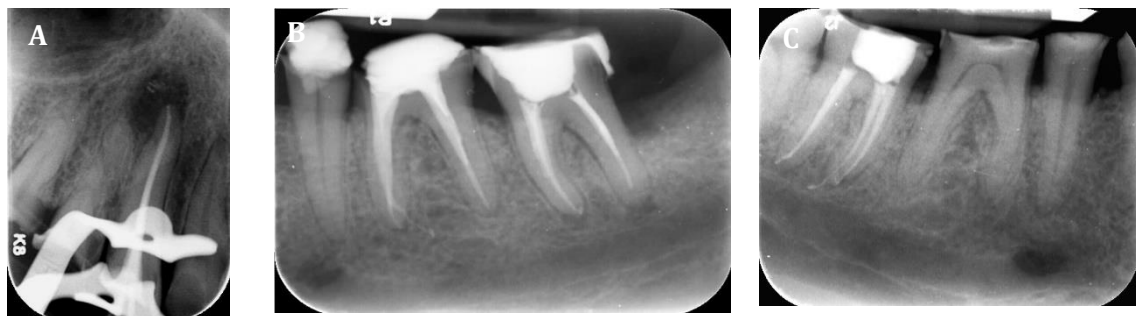
Figure 4. Post endodontic treatments on teeth 13 (A), 36, 37 (B), 47 (C)

The initial preventive treatment phase was first initiated and this includes oral hygiene maintenance and dietary changes as well as caries management. Endodontic treatments were carried out on teeth 13, 37 and 47. Elective endodontic treatment was also performed on 36 (Figure 4A-C).

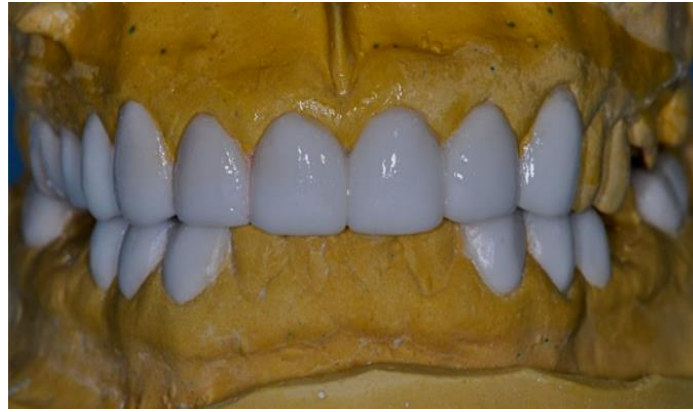
Figure 5. Articulated diagnostic wax up

Diagnostic wax-ups were made at an increased vertical dimension on articulated

study casts using semi-adjustable articulator (Denar® Mark II, Whipmix) (Figure 5). Chairside intraoral mock-up was done with temporary bis-acrylic material (Protemp™ 4, 3M™) to assess the aesthetic and smile line of the planned final restoration (Figure 6).

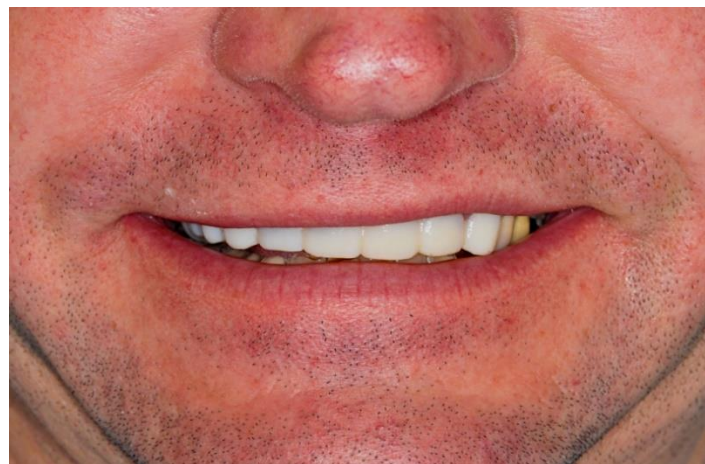
Figure 6. Intraoral mock-up with bis-acrylic temporary crown material

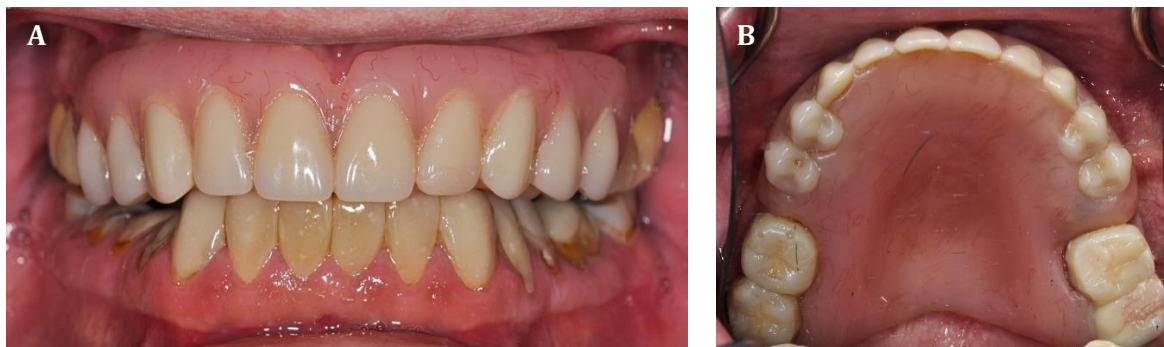
Figure 7. Provisional upper acrylic partial tooth-supported overdenture (A) and provisional crowns on upper molars (B)

Provisional upper partial tooth-supported overdenture was constructed to the desired VDO, covering teeth 15 to 25 where the abutment teeth were shaped into dome and restored with composite resin. Posteriorly, provisional resin crowns were placed on all his remaining upper molars (Figure 7A-B). The patient was reviewed every 2 weeks for the total duration of 3 months until the temporary prosthesis and composite restorations were deemed stable.

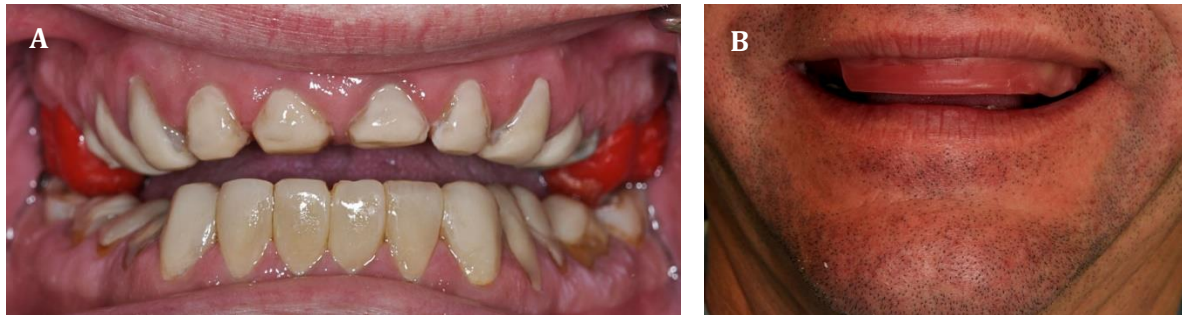
Figure 8. Utilizing resin copings to stabilise the existing vertical dimension during jaw registration stage (A). Upper wax rim to stabilize the vertical dimension and labial support (B).

After his oral condition stabilizes, master impression of the prepared molars was done for construction of milled porcelain-fused-metal (PFM) crowns. For bite registration, pattern resins crowns were used and chairside occlusal resin beading was performed to maintain the same vertical dimension, as the temporary crowns were

removed one at a time (Figure 8A). Anteriorly, upper wax rim was used to stabilize the vertical dimension and reconfirm the labial support (Figure 8B).

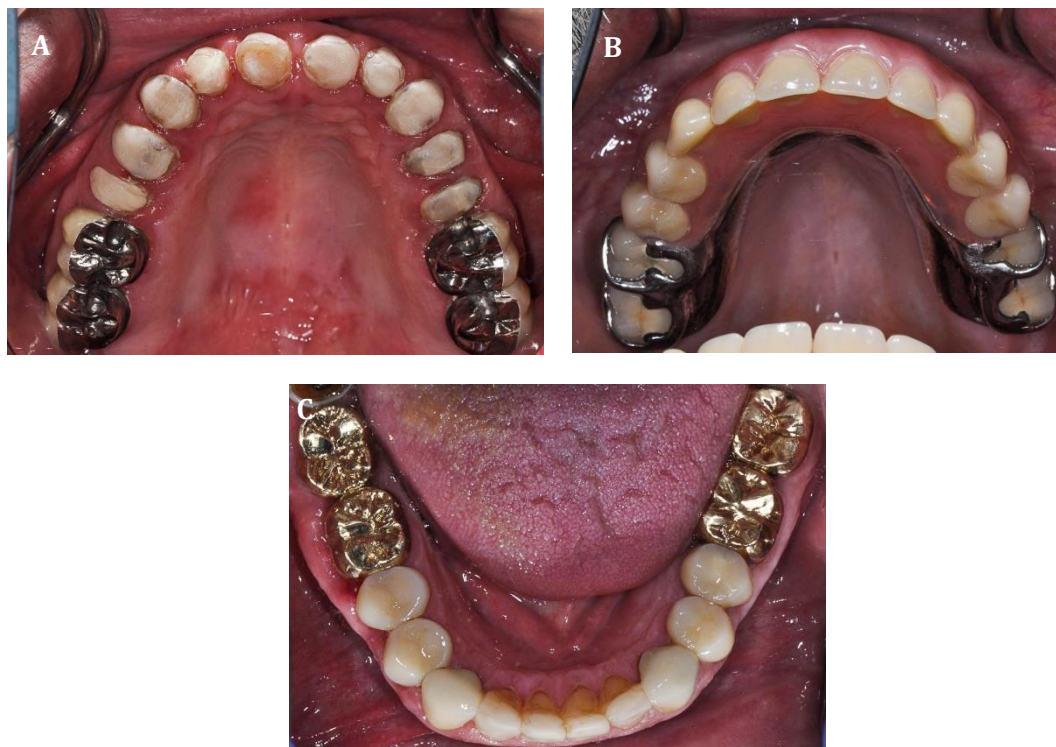
Figure 9. Maxillary molars fitted with PFM crowns with milled rest seats and palatal guideplanes (A), supporting a cobalt-chrome partial denture (B). Posterior fixed prostheses on the lower arch with composite resin build up on the anterior teeth (C).

Definitive metal ceramic crowns with milled palatal ledges were cemented with resin cement and maxillary cobalt chrome

overdenture was issued (Figure 9A-B). On the mandibular arch, composite resin build-ups were done on the four incisors, while the canines and premolars were fitted with composite crowns. Full gold crowns were

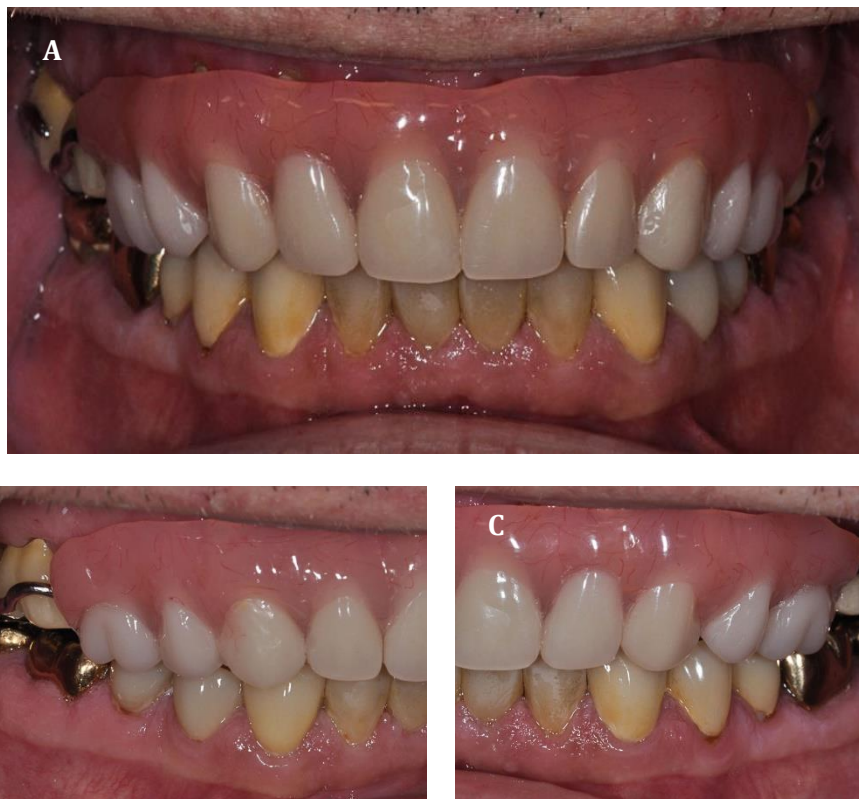
Figure 10. Frontal view (A), right buccal view (B) and left buccal view (C) of the final treatment

issued to the molars (Figure 9C, 10A-C, 11A-C). The patient was reviewed after 1 week, followed by 3 months and 6 monthly intervals to ensure that oral hygiene is up to optimal condition.
