Vanishing Heritage: Values of Wooden Minaret Mosque Brezovača

This paper aims to explain values of wooden minaret mosque of Bosnia. Furthermore, case study of Brezovača mosque located in northern part of the county was elaborated and the aim of this paper was to justify need to regain original shape and to explain proposed interventions relating on similar structure from the close vicinity. This approach was accepted due to lack of source that would confirm exact information about this building.

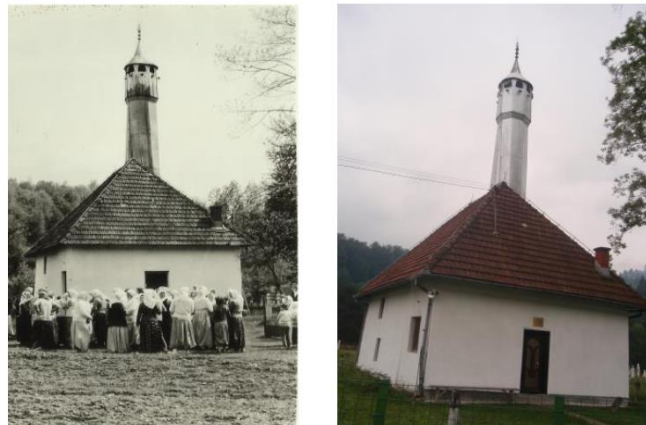
Fig.1: Brezovača mosque around 1975/80 (left) and today (right)
(Source: Nuraga Softić)

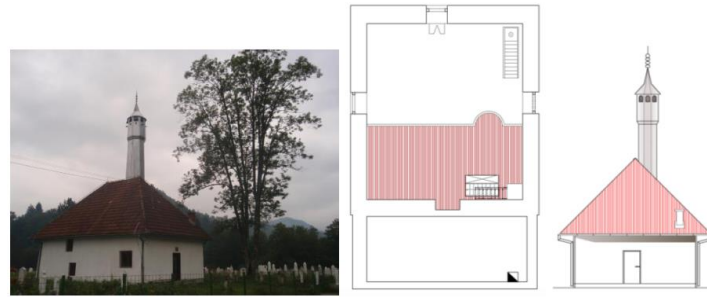
Mosque is covered with pitched roof maid of wooden beams, covering both, porch and main praying hall. Currently clay roof tiles are used as roof covering, while originally for the roof covering was used wooden shingle as it was commonly used in Bosnia. Base of minaret is placed in the roof and total height of the minaret is around 16 m from the terrain and 8 m from the peak of the roof. Minaret is maid of wooden skeleton with spiral stairs that is toward top enlarged into balcony (serefe). Minaret cuts the surface of the roof and it is fixed for the roof construction in the place of section point of roof and minaret. Gallery of the minaret is covered with small openings. Today minaret is completely covered with sheet metal.

Fig. 2: Brezovača mosque condition in 2012

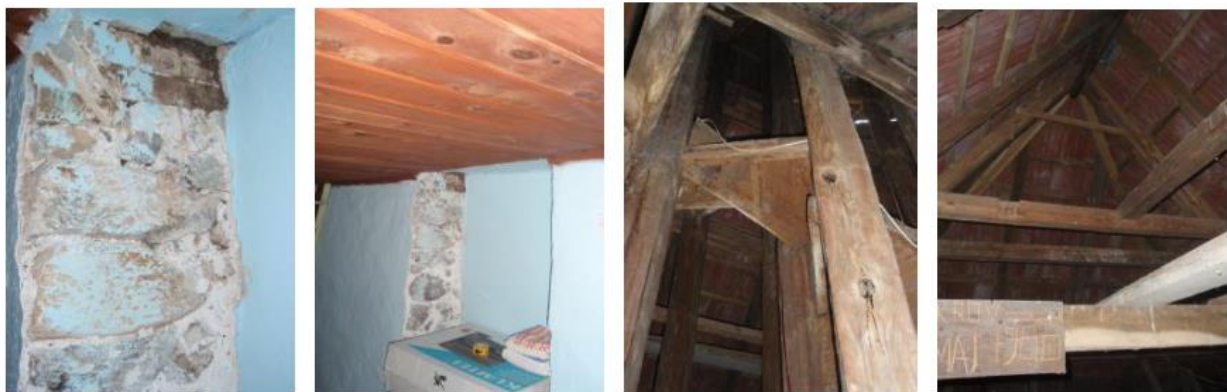
Fig. 3: Brezovača mosque condition of the wall and roof beams in 2017

According to the site inspection mosque is still in use and this is the main mosque for the surrounding villages. Survey of the Brezovača mosque showed some of the inappropriate interventions including replacement of open porch with closed walls, replacement of traditional roof covering with clay roof tiles and wooden minaret is fully covered with metal sheet. Unfortunately, with this interventions authenticity of the mosque is harmed. Basic structure of the building does not reflect any severe damage or cracks. Roof beams are dating back to 1988, without permanent protection and therefore most of them should be replaced with new one.

For Brezovača mosque future interventions should include structural enhancement to ensure stability of all structural parts with possible replacement of worn out elements (roof beams). Both interiors and exterior of the mosque should be improved with correcting some of the mistakes occurred due to lack of proper technical guidance and maintenance, using inappropriate materials (color of façade, roof and minaret covering etc.). Since Brezovača mosque is a village mosque it is possible to assume that there was no rich decoration.

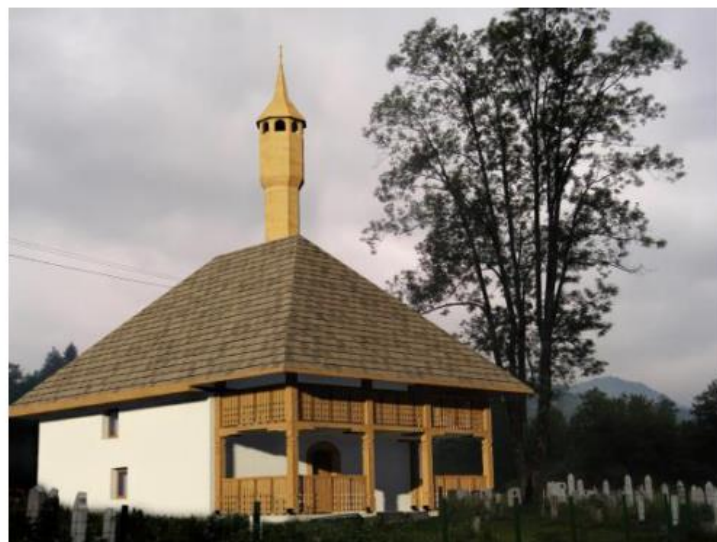
Fig.4: Brezovača mosque proposed restoration

Due to lack of knowledge of its original shape it is possible to analyze elements of the other mosque in this region such as mosques of Tuzla region. Some of the still existing wooden minaret mosque from this area e.g. Brdska mosque and Mejdanska mosque in Tuzla, depict the manner in which they were shaped. The porch was one of the main element of the mosques of the time in which they have been built. Therefore, beside above mentioned interventions, the mosque should regain its local character with open porch.

Inspecting mosque there is obvious difference in wall thickness of main corpus and walled porch. This fact once more confirms that structure had open porch in the front part. According to the above mentions narratives of old mutevelis of the mosque porch had two story and this might be confirmed due to existing niche in the gallery wall inside the mosque. The niche was possibly place of door to the upper gallery of the porch.

In absence of recorded information about historical structure, as it is case for the Brezovača mosque, it is recommended to use possible similar structure from the close vicinity or region, as model for analogy. From the existing preserved sample, it is possible to determine basic elements of the structure, to discover way of constructing, relation and proportions of elements. Relaying on several existing examples in the region the open porch was determined as one of peculiarity and for the Brezovača mosques it was possible to confirm this assumption relaying on the narratives and traces in the wall. Following all available information, including narratives, old photo documents and inspecting structure in situ the shape of elements are confirmed. Gained results were used for the proposed reconstruction of destroyed part of the porch and restoration of the mosque (figure 4.)
