## THE RELOCATION, CONSERVATION AND PRESERVATION OF KAMPUNG TELUK MEMALI MOSQUE IN IPOH, PERAK MALAYSIA

\*Ar. Azim A. Aziz<sup>1</sup>

<sup>1</sup>ATSA Architects Sdn. Bhd., Malaysia

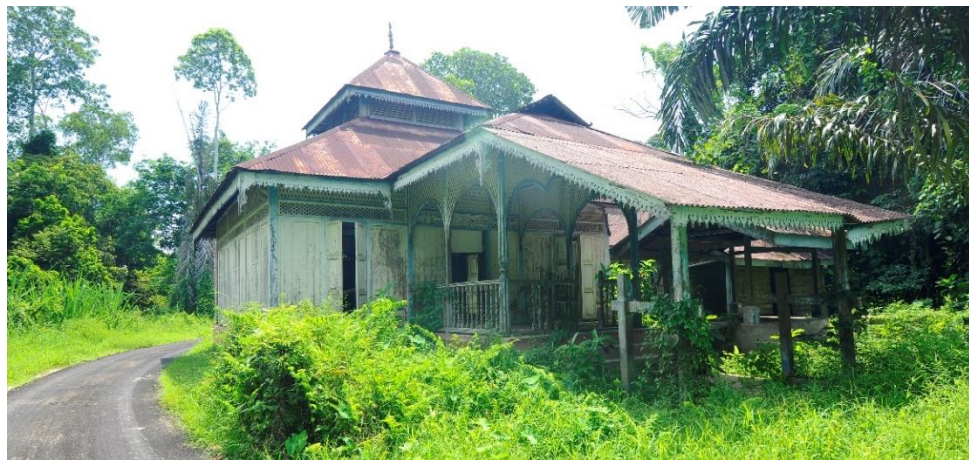
**Fig. 1** The mosque on the old site in Kg. Teluk Memali, Kg. Gajah, Perak  
Source: (ATSA Architects, 2015)

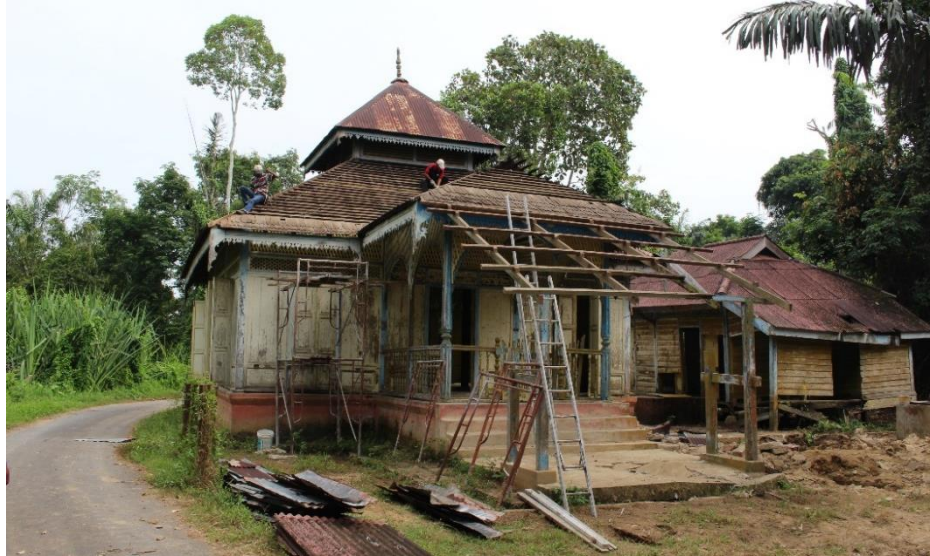
**Fig. 2 The dismantling works of the mosque on the old site**

The dismantling works are the most crucial stage in any relocation practice. Based on the methods of dismantling works implemented in this mosque, the dismantling works can be divided into six major components that involved structural components of timber structures, which are the roofing, wall panels, floorings, joists, tie beams and columns in 24 to 29 detailed steps altogether.

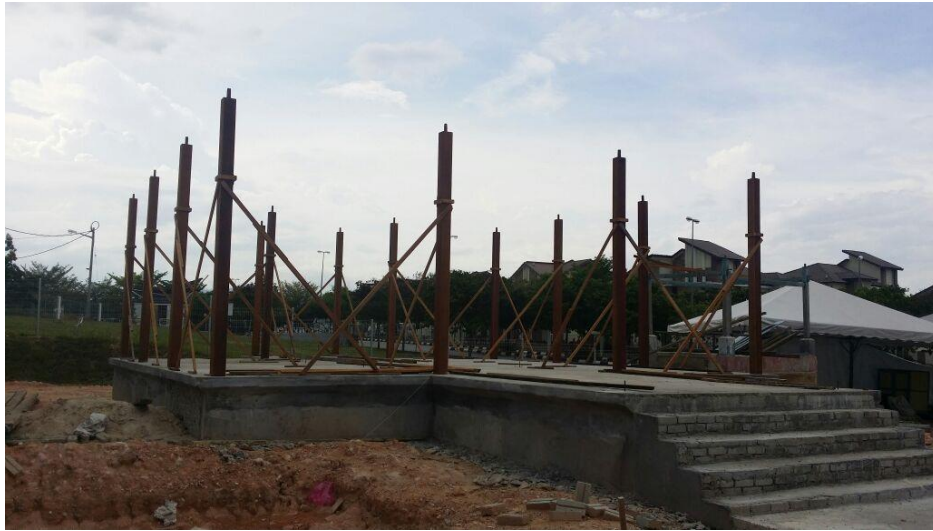
**Fig. 3** The reinstalled columns temporarily supported by wooden bracings  
(Source : ATSA Architects, 2016)

The reinstallation method began with the fixing up the concrete base, either the platform base or the normal pad footings for elevated timber structures. The process then commenced with the reinstallation of the *tiang seri* or *soko guru* columns, followed by other supporting columns and crossbeams to fully erect the structural frames. After this temporary structure has been erected, it is critical to support this structure temporarily by using wooden bracing supports attached to the columns and crossbeams.

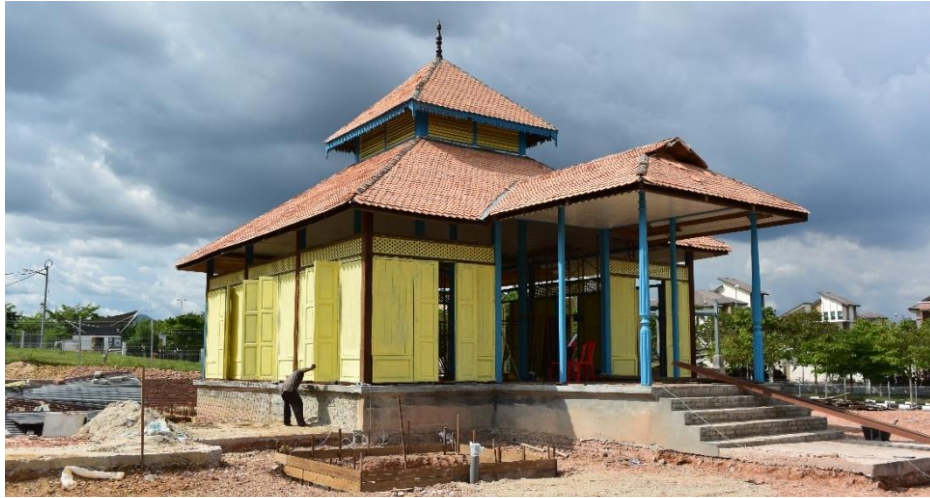
**Fig. 4** The partially completed restored mosque on new site  
(Source : ATSA Architects, 2016)

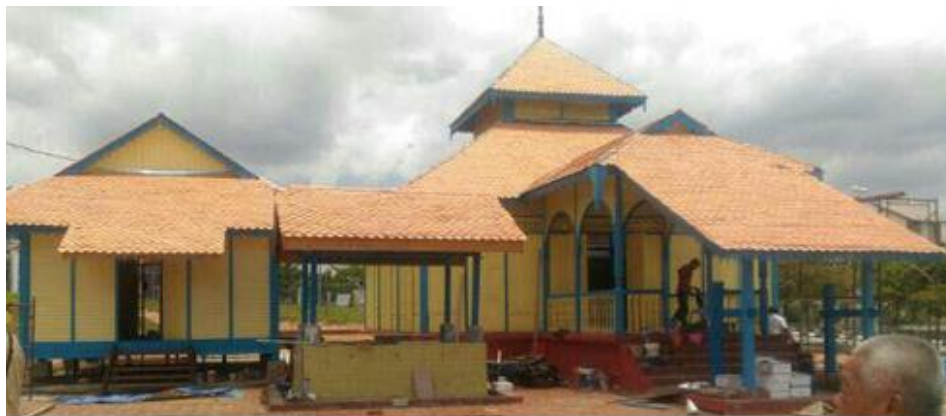
**Fig. 6** The nearly completed mosque building and its surrounding  
(Source : ATSA Architects, 2017)
