Restoration of posterior tooth with single shade composite: A case series

The purpose of this study is to present three different cases that uses single shade composite to restore carious posterior tooth.

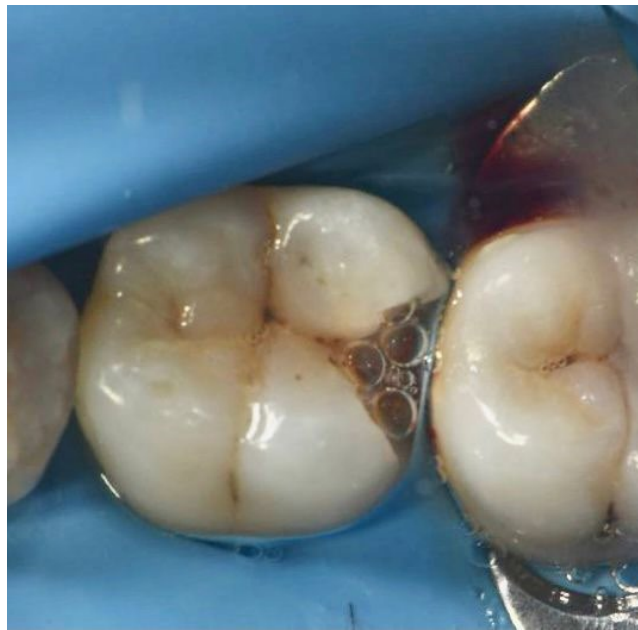
Figure 1. Pre-operative: Disto-occlusal cavity of tooth 36 with no restoration

A 27-year-old female patient came with complaints of sensitivity and food stuck after meal on her lower left back tooth. She is medically fit and healthy. Intraoral examination revealed caries on disto-occlusal of tooth 36 (ICDAS code 05). Pulp sensibility testing was done, and the tooth responds normally to both electrical pulp test (EPT) and cold test. The diagnosis made was reversible pulpitis. Upon discussion with the patient, it was decided to restore the tooth with single shade composite restoration. After obtaining the patient's consent, local anesthesia infiltration with one cartridge of 2% mepivacaine with 1:100 000 epinephrine was given. Shade selection was done, and Kerr SimpliShade Medium (Kerr Company, USA) was selected. Then, multiple teeth isolation was done with rubber dam on tooth 35 until 37. Clamp was ligated with floss and placed on tooth 37.

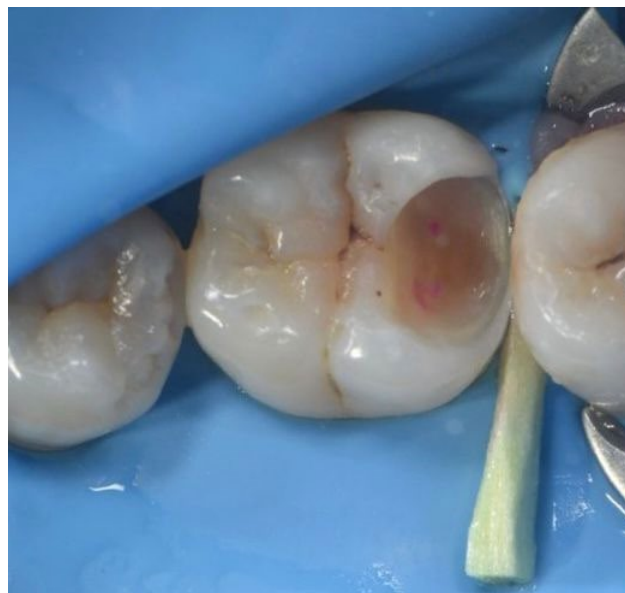
Figure 2. Caries removal and cavity preparation: Caries removal was done on disto-occlusal of

36

Removal of caries was done with round bur mounted on high-speed handpiece. Any unsupported enamel was removed. Prior to restoration of the proximal wall, Garrison sectional matrix and wedge was placed and stabilized. Since the caries removal reveals some pulpal shadowing, a thin layer of calcium hydroxide liner (CaOH) or dycal was placed as base at the deepest cavity with Glass Ionomer Cement (GIC) Fuji VII as liner.

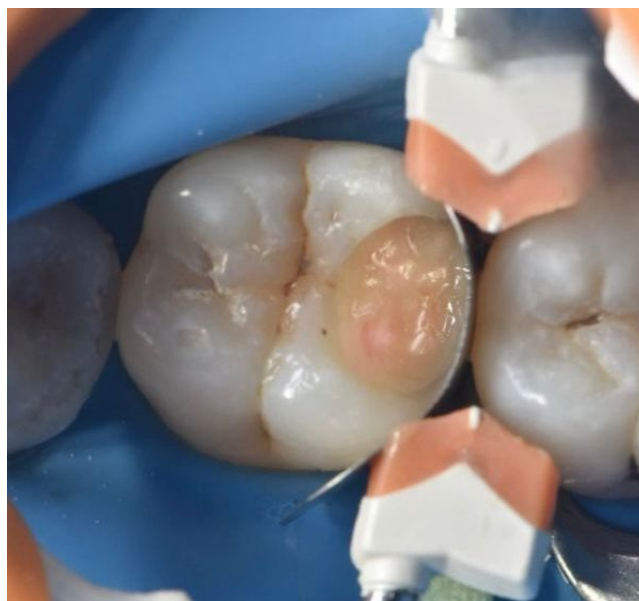
Figure 3. Composite placement: Garrison sectional matrix was placed on distal of 36 and Kerr SimpliShade Medium was used to restore the cavity

Then, the tooth was etched with Kerr's etchant (Kerr Company, USA) of 37.5% phosphoric acid for 30 seconds on enamel and 15 seconds on dentine and washed thoroughly and dried. Kerr OptiBond Universal (Kerr Company, USA) was placed with microbrush and cured for 10 seconds. Kerr SimpliShade Medium (Kerr Company, USA) is placed into cavity incrementally and cured according to the manufacturer. Any excess was trimmed with white stone bur

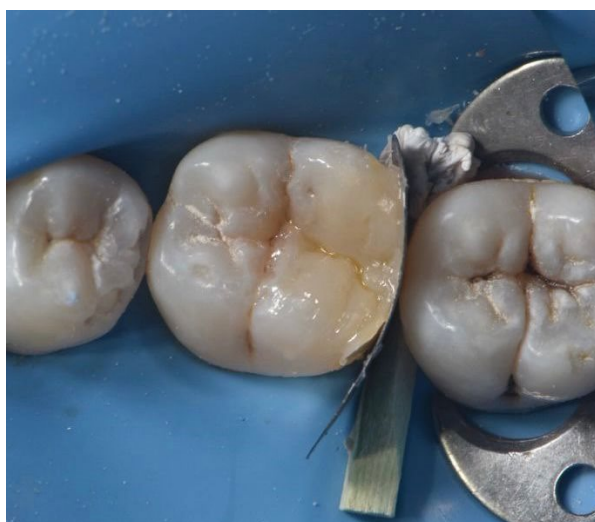
Figure 4. Composite placement: Kerr SimpliShade Medium was used to build the tooth occlusal contour

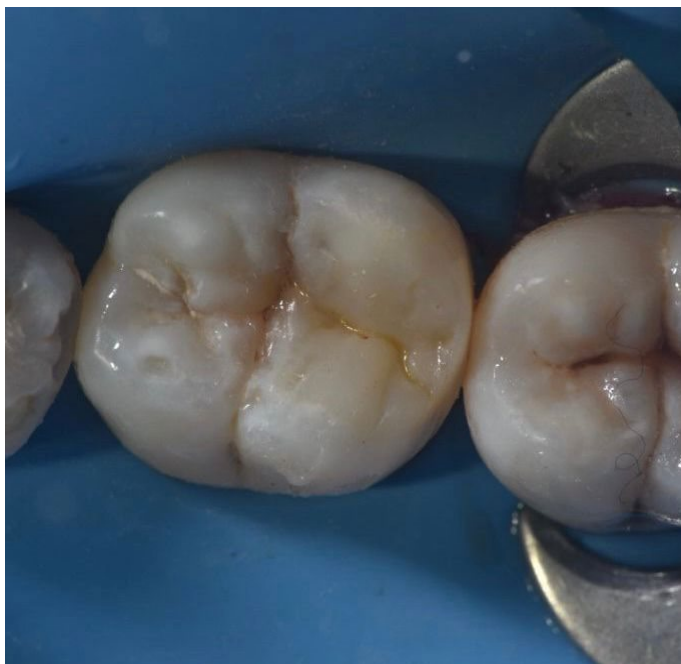
Figure 5. Excess removal: Any excess composite was trimmed with white stone bur

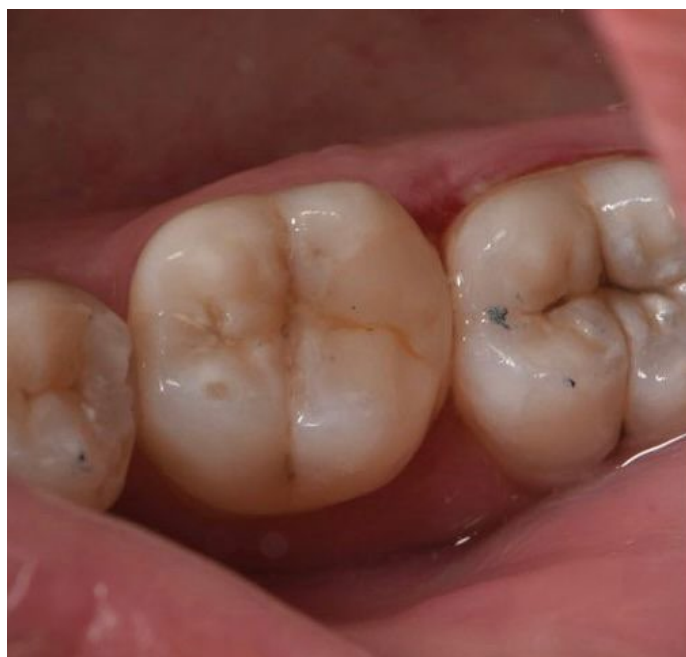
Figure 6. Final restoration: Occlusion was assessed with articulating paper and polishing with Soflex disc course and Eve Diacomp Twist was done

mounted on high-speed handpiece. Rubber dam was removed, and occlusion was assessed with articulating paper. Final restoration was polished with Soflex disc course and Eve Diacomp Twist. Patient was encouraged to maintain a good oral hygiene and advised to attend dental clinic once a year for maintenance. Patient was satisfied with the restoration and did not experience any pain or sensitivity at one week review visit

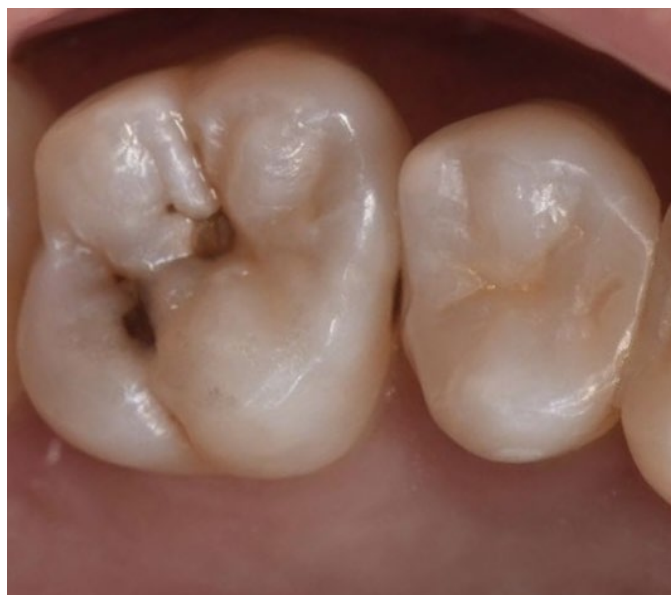
Figure 7. Pre-operative: Occlusal and mesial caries on tooth 26 without any restoration

A 25-year-old female Malay came with a complaint of food stuck and sensitivity on her upper left back tooth. She is medically fit and healthy. Upon intraoral examination, there is caries on occlusal and mesial of tooth 26 (ICDAS code 04). There is no pain on palpation and percussion. Pulp sensibility reveals a positive response with no exaggerating pain on both electrical pulp test (EPT) and cold test. The diagnosis made was reversible pulpitis. Upon discussion with the patient, it was decided to restore the tooth with single shade composite restoration. After obtaining the patient's consent, local anesthesia infiltration on buccal and palatal mucosa with one cartridge of 2% mepivacaine with 1:100 000 epinephrine was given. Shade selection was done, and Kerr SimpliShade Medium (Kerr Company, USA) was selected. Then, multiple teeth isolation was done with rubber dam on tooth 24 until 26. Clamp was ligated with floss and placed on tooth 37.

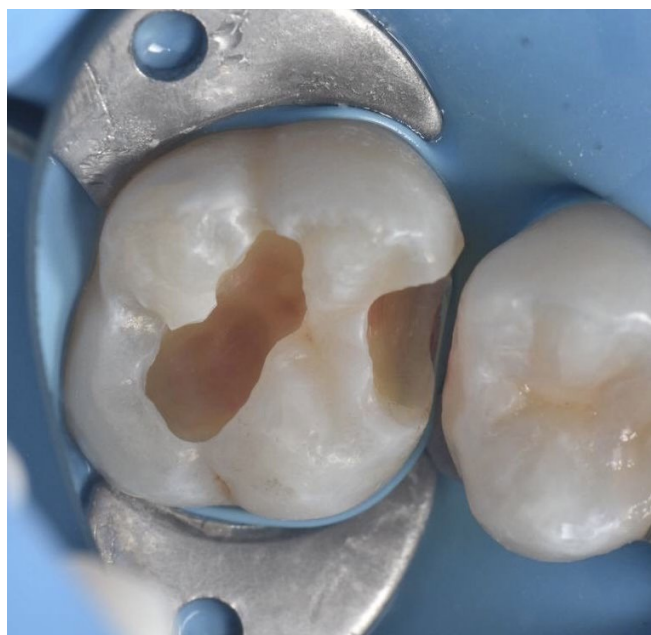
Figure 8. Caries removal and cavity preparation: Caries was removed on mesial and occlusal of 26

Caries was removed with round diamond bur mounted on high-speed handpiece. Any

unsupported enamel was removed. Sectional matrix and wedge were placed on mesial of tooth 26 before restoring with composite. Then, the tooth was etched with Kerr's etchant (Kerr Company, USA) of 37.5% phosphoric acid for 30 seconds on enamel and 15 seconds on dentine and washed thoroughly and dried. Kerr OptiBond Universal (Kerr Company, USA) was placed with microbrush and cured for 10 seconds.

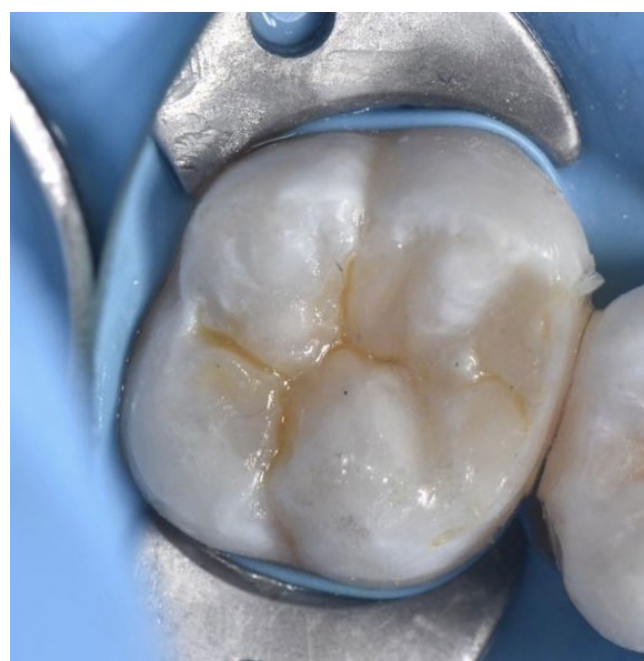
Figure 9. Composite placement: Composite placed incrementally and shaped to mimic tooth anatomy

Kerr Simplishade Medium (Kerr Company, USA) composite was placed incrementally and cured according to the manufacturer. Occlusion was checked and any high bite or discomfort was removed with white stone bur mounted on high-speed handpiece. Once satisfied, the restoration was polished with Soflex course and fine disc and Eve Diacomp twist. Post-operative instruction was given, and patient was advised to visit dental clinic annually for maintenance of oral health. Patient was satisfied with the restoration and there was no pain or sensitivity at one week review visit.

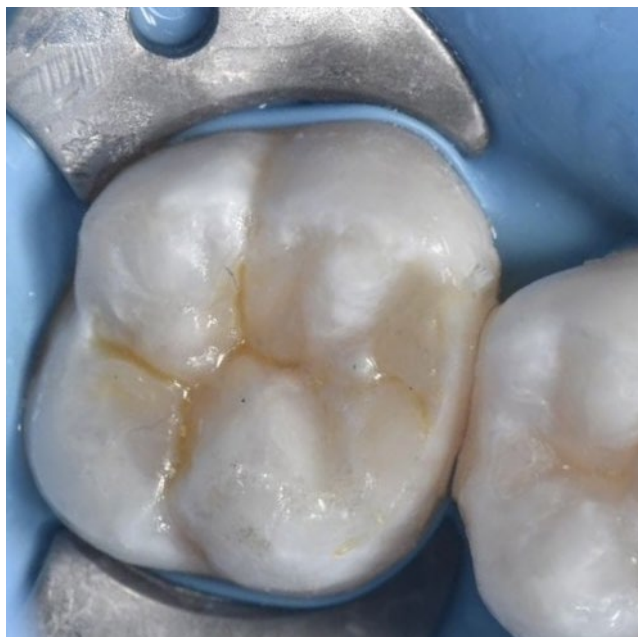
Figure 10. Excess removal: Minor adjustments were made prior to removing rubber done

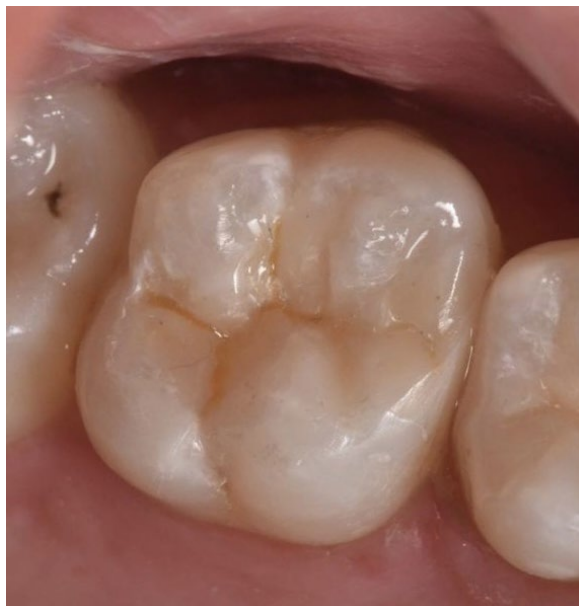
Figure 11. Final restoration: Removal of any high bite and final composite polishing

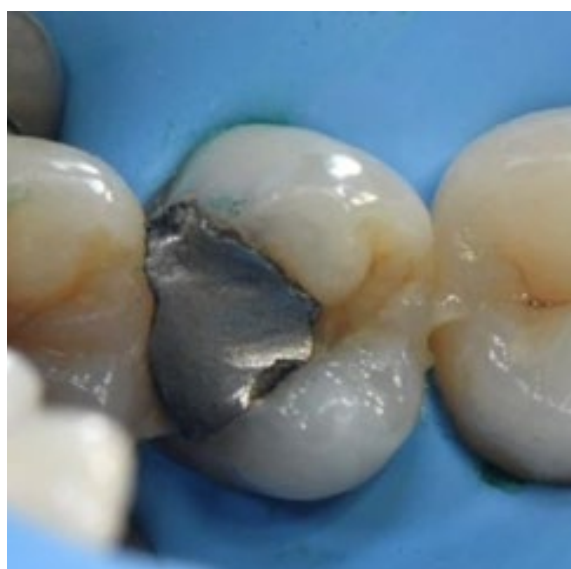
Figure 12. Pre-operative: Disto-occlusal amalgam restoration with excess on distal and deficiency on restoration-tooth interface.

A 35-year-old female patient came to dental clinic complaining of sensitivity and food stuck after meal on her upper left back tooth. She is medically fit and healthy. Intraoral examination showed presence of amalgam restoration on disto-occlusal of 25 with excess on the distal inter-proximal area and deficiency on the restoration-tooth interface (ICDAS code 43). The tooth responds normally to both electrical pulp test (EPT) and cold test, hence, a diagnosis of reversible pulpitis was made. It was decided to restore the tooth with single shade composite restoration and the patient provided consent for the treatment. Local anesthesia infiltration with one cartridge of 2% mepivacaine with 1:100 000 epinephrine was given. Shade selection was done, and Kerr SimpliShade Medium (Kerr Company, USA) was selected. Then, multiple teeth isolation was done with rubber dam on tooth 24 until 26. Clamp was ligated with floss and placed on tooth 26.

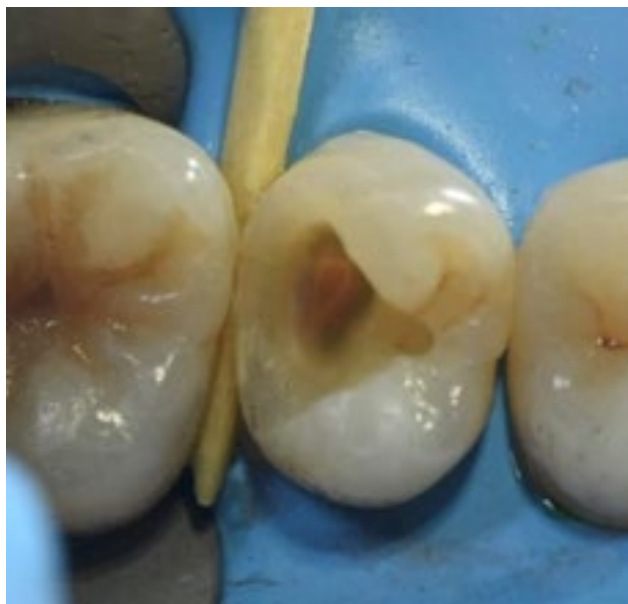
Figure 13. Caries removal: Amalgam restoration removed and caries removal

Round diamond bur mounted on high-speed handpiece was used to remove amalgam restoration of tooth 25. Then, caries was removed, and any unsupported enamel was

removed. Sectional matrix and wedge were placed on distal of tooth 25 before restoring with composite. Following caries removal, some pulpal shadowing can be seen, hence, a thin layer of calcium hydroxide liner (CaOH) or dycal was applied at the deepest cavity as base with Glass Ionomer Cement (GIC) Fuji VII as liner. Selective etching with Kerr's etchant (Kerr Company, USA) of 37% phosphoric acid was done on enamel for 15 seconds and rinsed thoroughly and dried. Kerr OptiBond Universal (Kerr Company, USA) was placed with microbrush, lightly blew, and cured for 10 seconds.

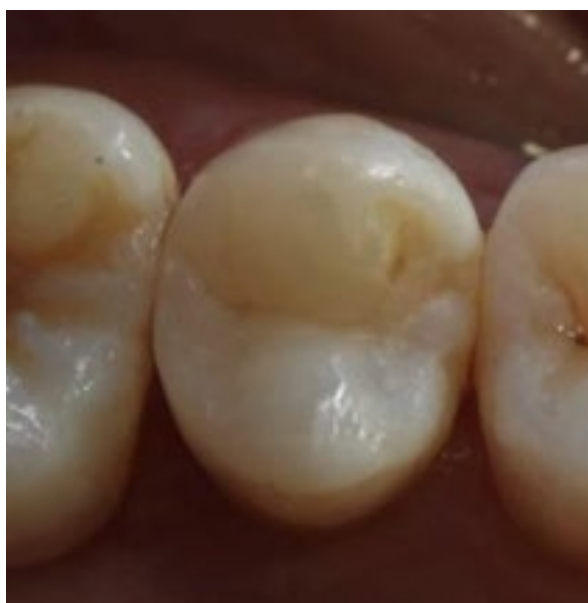
Figure 14. Final restoration: Removal of high bite and final composite polishing

Kerr Simplishade Medium (Kerr Company, USA) composite was placed incrementally and cured adequately. Occlusion was checked with articulating paper and any high bite or discomfort was removed with white stone bur mounted on high-speed handpiece. Once satisfied, the restoration was polished with Soflex course and fine disc and composite rubber polisher. Post-operative instruction was given, and patient was advised to visit dental clinic annually for maintenance of oral health. Patient was satisfied with the restoration and did not have any pain or sensitivity at one week review visit.
